Gold King Mine spill

Animas River Basin - Southwest Colorado - August 2015

Water Quality Control Division

*Report compiled
January 2016*

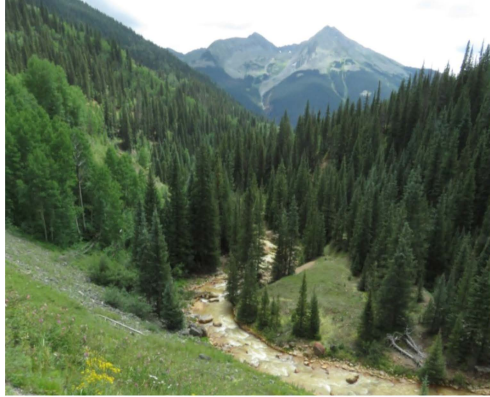
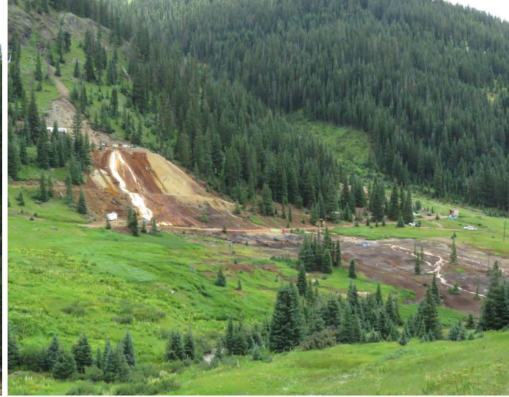
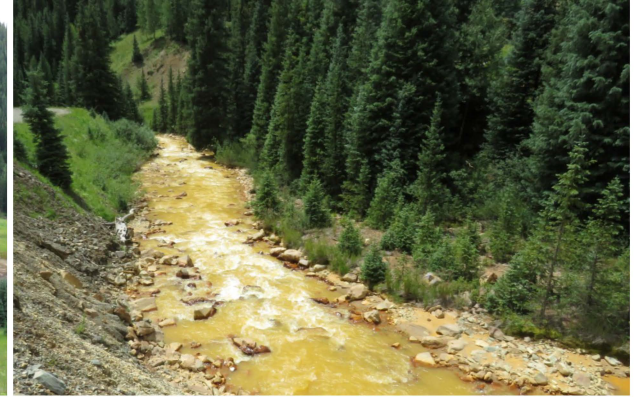
On August 5, 2015, an EPA team was working to investigate on-going water releases from the mine and assessing the feasibility of further mine remediation. During the excavation, 3 million gallons of mine waste water was unexpectedly released into Cement Creek. The contaminated water traveled for a week down the Animas River, joined the San Juan River in New Mexico and finally the Colorado River and Lake Powell in Utah.
